# A LARGE EUROPEAN IRON CHAMBER CLOCK

John A. Robey

*A large weight-driven iron chamber clock is discussed. It originally had trains of only two-wheels. Changes to the balance escapement and motion-work have resulted in the dial being repainted to read counter-clockwise. Analysis of the paint indicates a date prior to 1650 and a name on the frame suggests a Polish origin.*

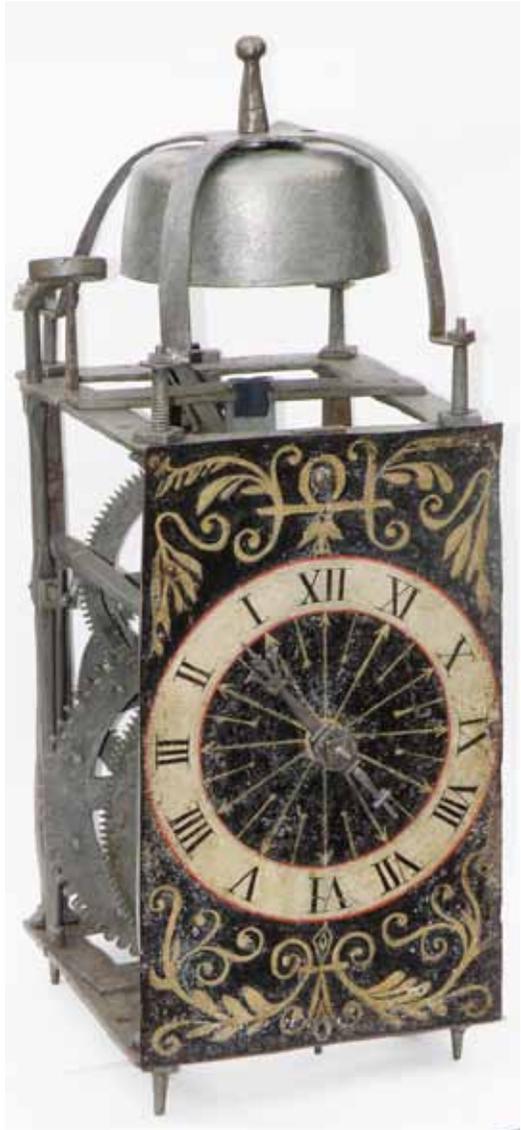
Fig. 1. Large iron clock with iron dial, standing 23in tall. The hand is a restoration.

The clock shown in Fig 1 is an interesting example of a large domestic clock made solely of forged iron, apart from later modifications. In Germany large early iron clocks are sometimes called *Klosteruhren* (monastery clocks), although they are more likely to have been used in a castle, manor house or large farm, rather than a religious building. The striking train has only two wheels and a fly. Similarly the going train would originally have had only two wheels with a crownwheel-and-verge escapement and a balance, later converted to a short verge pendulum and subsequently to its present tic-tac anchor escapement. These changes are almost inevitable on a pre-pendulum clock and any early example that has not had the escapement updated needs to be examined very carefully to establish its authenticity. In the nineteenth and early twentieth centuries fake copies of Gothic clocks and very early iron clocks were made from authentic wrought iron using the correct smithing techniques, which means that they are now very difficult to distinguish from the real thing. The author is satisfied that the clock is genuine and this has been confirmed by analysis of the paint on the iron dial. The most noticeable unusual feature is the anti-clockwise direction of the hour numerals. This can be explained by changes to the balance escapement and motion-work, the latter due to the method of letting off the strike on early clocks.

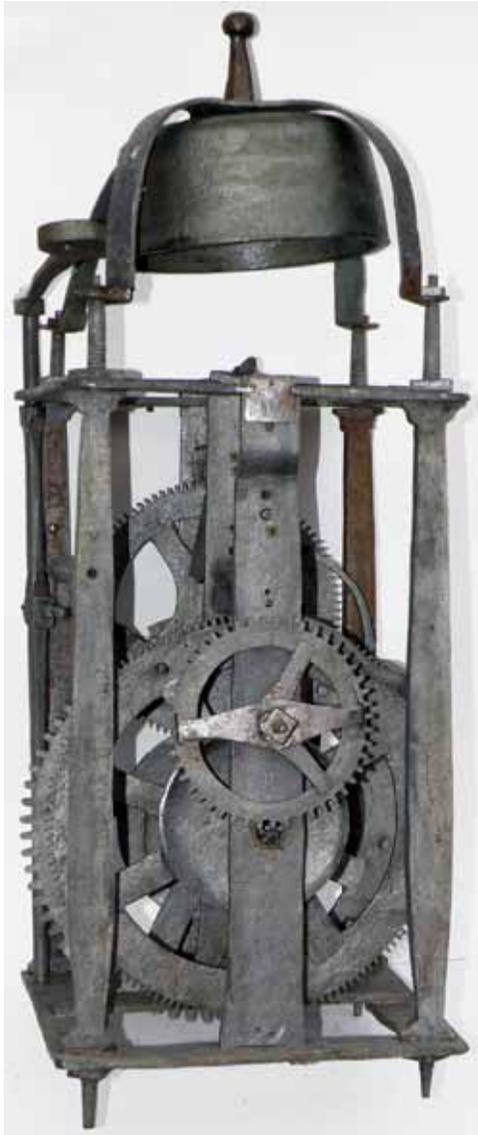
Fig. 3. Front of the all-iron movement with just the original wheels and the later dial wheel. Note the slim baluster-shaped pillars and the pin on the going greatwheel to let off the strike.

Figs 3-6 show the movement without the later brass wheels and pallets of the present tic-tac

escapement. The posted-frame consists of two flat open 'plates' fixed to the top and bottom of vertical flat baluster-shaped corner posts by square nuts. The lower ends of the posts are extended to form feet, while the upper ends of reduced diameter hold the bell strap with four smaller square nuts. The thick heavy bell, 6in diameter and weighing 4.8lb (2.2kg), has simple ringed decoration on the top and is held on the knobbed finial with a square nut. The total height of the clock is 23in. The rectangular dial, 13 $\frac{3}{4}$ in tall and

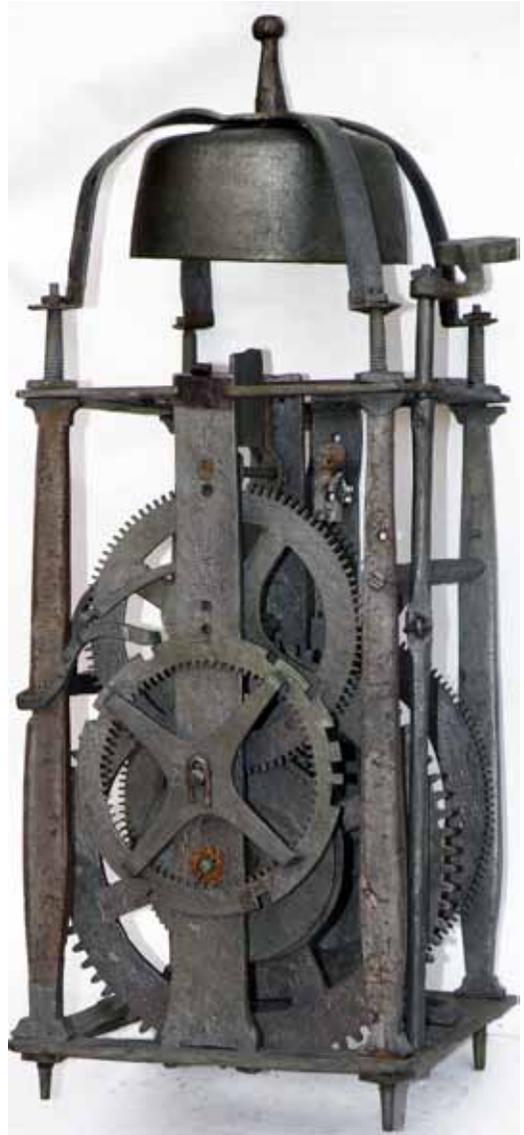
Fig. 4. Rear view showing the countwheel with slots on the outer edge, gear teeth on the inner edge and offset crossings. Only two wheels and a fly in the striking train.

As usual on early Continental clocks the slots and the gear teeth of the countwheel are both cut round the rim, in this case the slots being on the outer edge and the teeth on the inner edge. Offset crossings are necessary as normal crossing would interfere with either the pinion or the detent. This arrangement was only used in England on early turret clocks, with early domestic clocks invariably employing a separate gear wheel riveted to the countwheel. Instead of a four-pronged pinion of report filed into the end of the greatwheel arbor, as often found on early clocks, there is a separate pinion. Although it is a later replacement it must have the same number of teeth as the original, otherwise the countwheel would not rotate correctly and the strike would be out of sequence. The wheel and pinion counts are as follows:

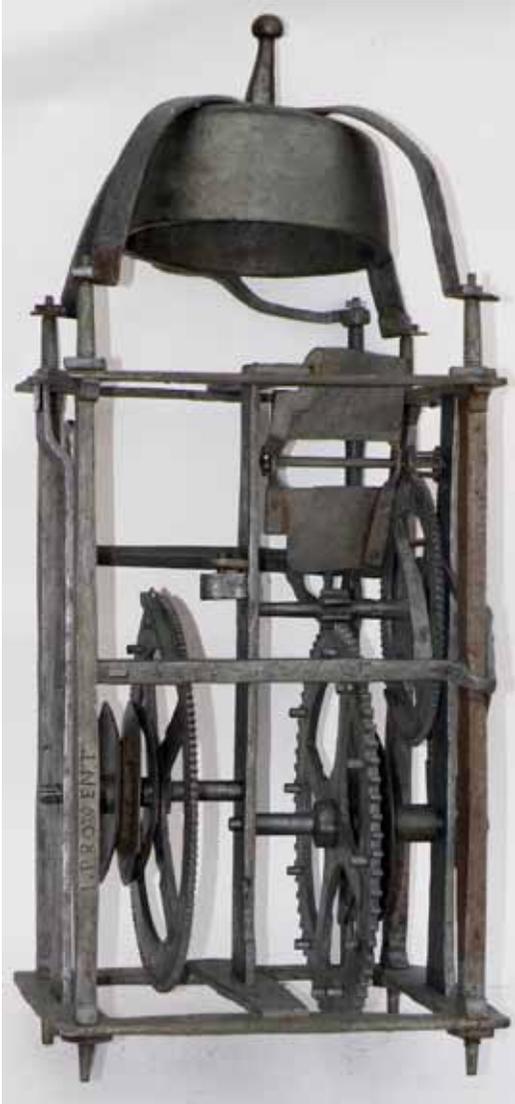
Fig. 5. Right-hand side with the single-arbor strikework. The bridge for the crownwheel of the original balance escapement survives on the central movement bar. Above it is the bottom block with an adjusting screw for the crownwheel of the replacement short pendulum escapement. The name 'I, PROWENT' can be seen on the left-hand pillar.

The central movement bar shows evidence for both the original balance and a later verge escapement for a short pendulum. The bridge into which the crownwheel pivoted survives, as does evidence for the broken off bottom block for the balance arbor. Not enough remains to determine whether the balance hung from a thread or was supported by an end 'stone' as in English lantern clocks. Just above the bridge are the bottom block (with an adjusting screw) and a rectangular hole for the potence of the replacement crownwheel of the short pendulum escapement. The verge pendulum probably hung at the rear of the movement, rather than in front of the dial in the German manner.

It is very unusual to find names, initials or dates on the dials or movements of Continental iron clocks of any period,<sup>13</sup> but this clock has 'I, Prowent' engraved on the right-hand front pillar. Regrettably this name (or any variant) is not that of any known clockmaker, nor has it been found as a surname in any European country. It is a very infrequently found surname in America, limited to only about a hundred people, but their country of origin has not yet been determined.

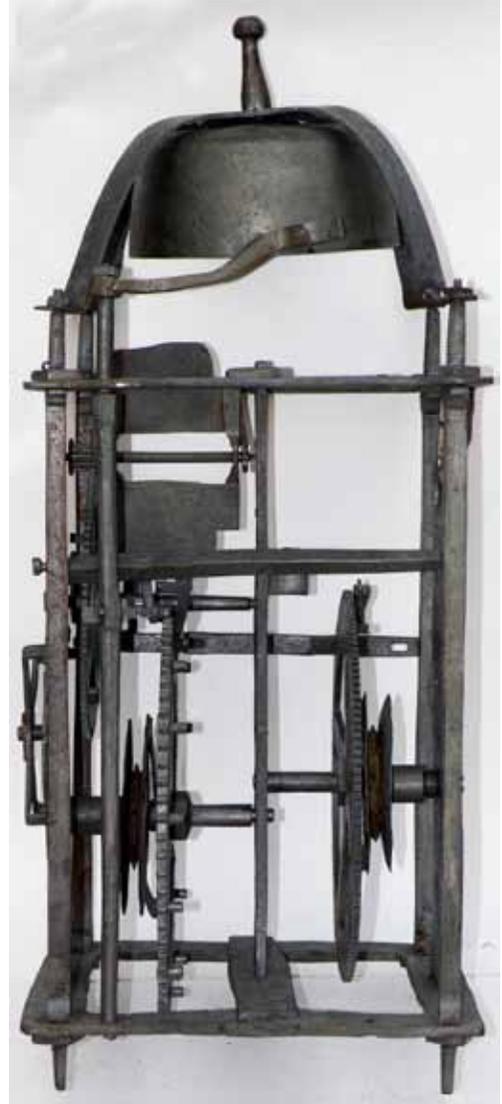
Fig. 6. Left-hand side showing the hammer head on the outside of the bell and the vertical shaft. The missing hammer spring and hammer stop ('counter') have since been restored. Note the large sheet-iron fly.

The heavy hammer head, which swings horizontally on a vertical shaft, has a hole through the centre, which appears to be deliberate, not a fault in the metal. Perhaps this was for a cord that could be pulled to one side to provide very simple, but effective, silencing at night.

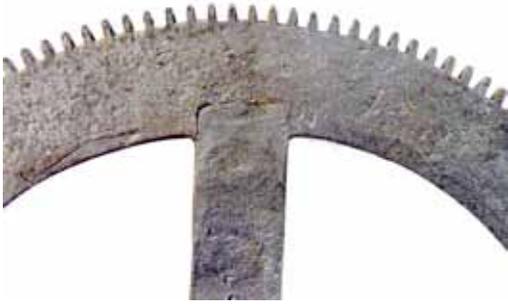
Fig. 7. The going greatwheel with a correctly formed join of the crossings to the rim.

The rims of the iron wheels have been forged from flat bar into circles and the joints, which can be detected, forge welded. To make the spokes (crossings), a bar was split from each end and opened up to form a cross, which was then forged flat. At first glance the ends of the crossings appear to be fitted into dovetailed recesses in the rim. However, a slag inclusion has caused part of one of the joints to break away and reveal the actual construction. The ends of the crossings have been split in two along their thickness and each side riveted into V-notches filed on the inside edges of the rims (Figs 7 and 8). Although the ironwork looks quite crudely made it is actually well forged by a competent smith with only a minimum of filing. The wheels run concentrically with virtually no wobble.

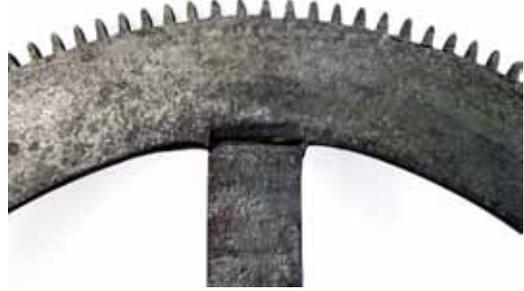
Fig. 8. A join with part broken off showing the end of the crossing fitting into V-notches filed into the inner edge of the rim.

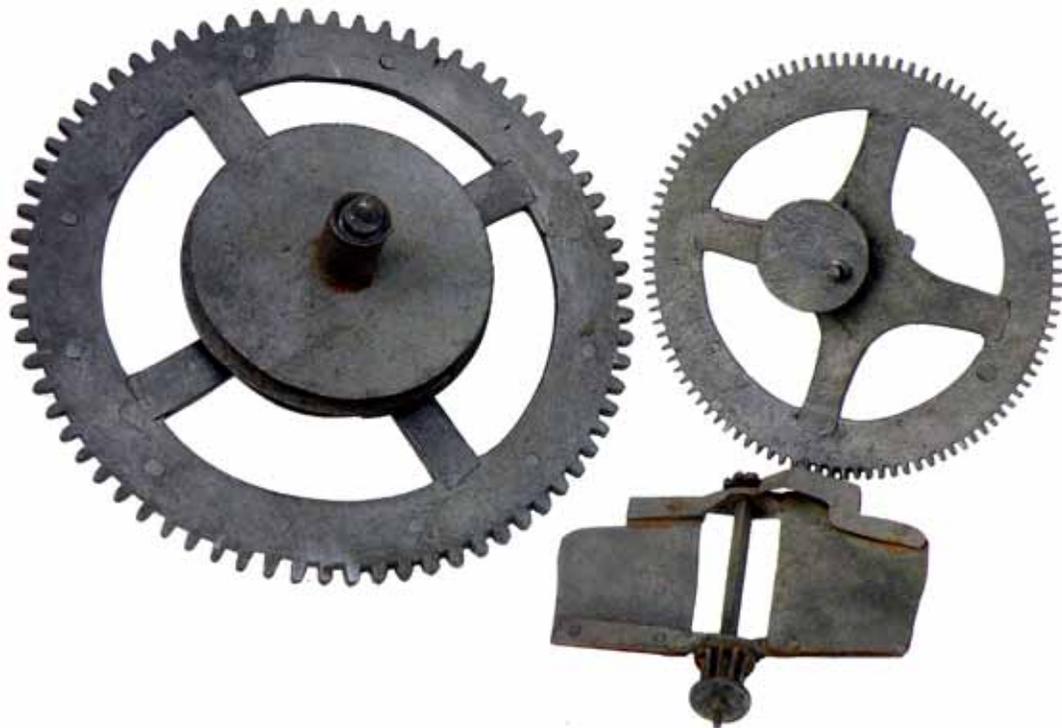
Fig. 9. The striking train of just two wheels and a fly. Note the later off-centre disc on the second arbor to provide overlift. The lantern pinion on the fly arbor is a later repair.

fly	-	9
locking wheel	100	- 6
greatwheel	72	- 12 (12 hammer pins)
countwheel	72

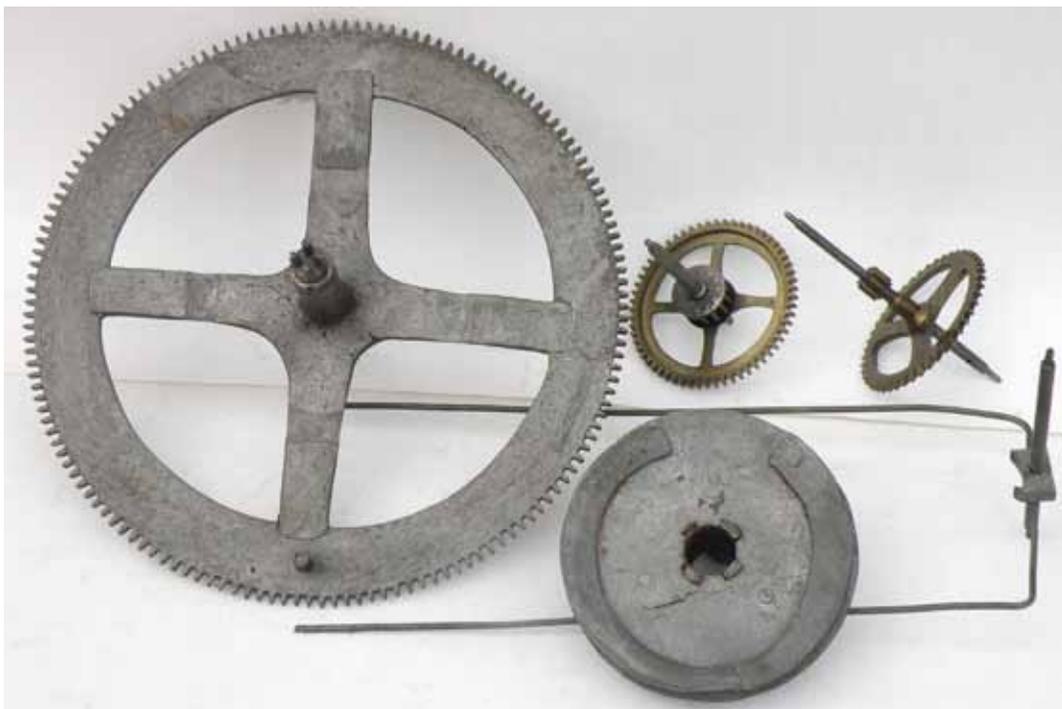
Fig. 10. The present going train with later brass second and escape wheels and tic-tac anchor pallets. The greatwheel arbor has a four-pronged pinion of report. Instead of the pulley being held together by rivets, four fingers on the sleeve are riveted into slots on the cheeks and hub.

The final update to the going train was to add a sub-plate to the rear of the front movement bar with new second and escape wheels of brass and tic-tac pallets. With the pallets being below the top plate a pendulum at the rear was impractical and two wires hang down either side of the arbors to act as an internal pendulum. These are not threaded and small bobs (now missing) may have slid on these, held by friction. The use of a bob on either side means that there is no need to crank the pendulum rod to avoid the arbors and allows for beat adjustment. The present going train (Fig 10), with replacement wheels and pinions in brackets, is:

escapewheel	(45)	-	(8)
second wheel	(60)	-	(12)
greatwheel	150	-	4
hour (dial) wheel	48

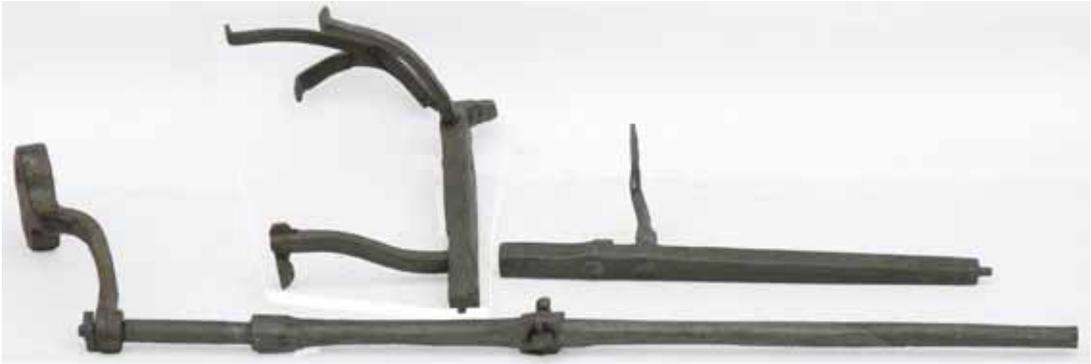
Fig. 11. Striking arbor with the nag's head and locking detent. The later overlift arm is riveted to the countwheel detent. The vertical hammer is in the foreground, with the hammer tail on its own arbor above it.

an overlift arm riveted to the locking arbor. This arm has been removed and replaced by an extension riveted to the countwheel detent contacting an off-centre disc, acting as a simple heart, fitted to the second (locking) arbor. Since the movement of the overlift detent on the heart is greater and the heart moves faster than the pins on the greatwheel, the action is more positive, so it was a sensible modification. Nag's head warnless striking is more reliable than is sometimes suggested.

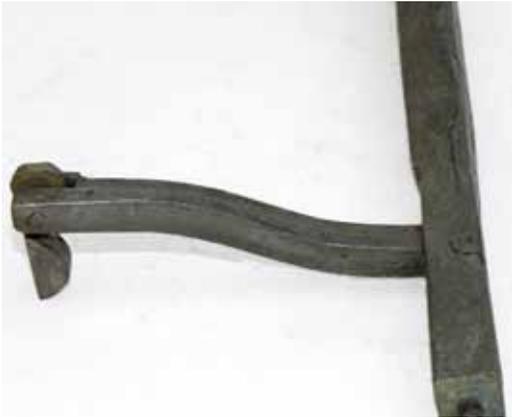
Fig 12 (left) Detail of the nag's head with gravity return

raises the nag's head clear of the pin and allows it to fall back on the trailing side of the pin, relocking the train after a single blow. Multiple strikes are controlled by the usual countwheel, as with warned striking.

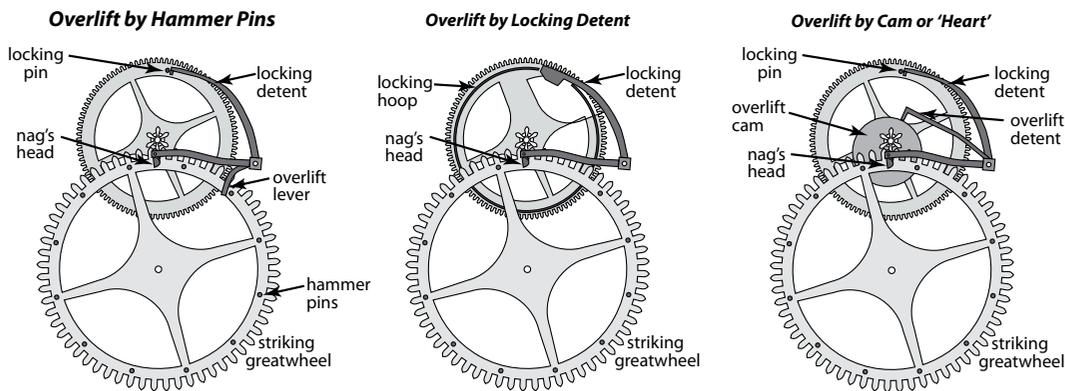
Fig. 13. Three methods of providing overlift for nag's head striking. A two-wheel striking train and an eccentric disc as a cam is shown, as on the Prowent clock. With three-wheel trains locking is on the third wheel with the cam (often with two slots) on the second wheel. The countwheel detent, on the same arbor as the other levers, is not shown. The nag's head is lifted by a pin on the going greatwheel (not shown), not, as it might seem, by a pin on the striking greatwheel.

Overlift can be achieved by three methods: the hammer lifting pins, by a slope on the locking detent running on a locking hoop, or by a cam on the second wheel arbor (Fig 13). The earliest clocks, including horizontal table clocks, used the hammer pins, but the favoured later method was a cam (called in German a *Herz* or heart, from its shape) with a slot to allow the overlift lever to drop and the system to relock. If, as here, the cam is on the same arbor as the locking wheel, then there is only one slot (*Einfach-Herz* or simple heart), but if the cam is on the next arbor it usually has two slots (*Doppel-Herz* or double heart). Note that, like a countwheel, the overlift detent does not lock in the slot, locking being by a separate detent acting on a pin on the second wheel. Only a hoopwheel performs the dual action of overlift *and* locking. On this clock overlift was originally by the hammer-lifting pins raising

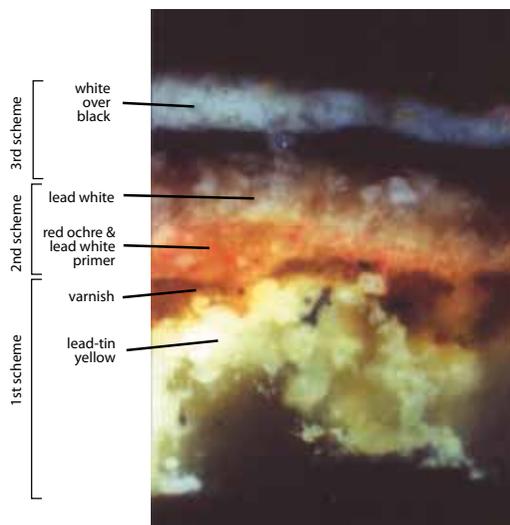
Fig. 14. Paint section through one of the scrolls on the top right of the dial at a magnification of 500x, showing the three different paint schemes. (Photo: C. Hassell)

The first scheme was a dark ground of a greenish black, probably a pigmented varnish or glaze, possibly a type of shellac, rather than a standard black oil paint (Fig 14). The scrolls were painted with a thin oil paint primer, a thicker coat of off-white and then a bright yellow, using the pigment lead-tin yellow. The

chapter ring was treated similarly, but with a top coat of pure white lead paint instead of yellow. Samples from the radiating lines in the centre show only the greenish black coating, implying that either there were no lines originally or they had flaked off. The inner and outer borders of the chapter ring were painted with pure vermilion. The whole dial was given a thin layer of varnish.

During the first repaint the dark ground was coated with a black oil paint and the scrollwork was underpainted with a reddish layer of lead white and red ochre then with white lead paint. The radiating lines in the centre were certainly present in this second scheme. The chapter ring was repainted with lead white oil paint and the red rings repainted with pure vermilion as before.
